**Subject: Response to ESPO Memorandum  
EPA ID NO: CAD009164021**

Project 207530 – Response to DTSC Letter to Martinez Refining Company (MRC) dated February 26, 2020 regarding Recommendations for the ETP-1 Biotreater Dike Stability Assessment Report for Martinez Refining Company LLC, Martinez, California. EPA ID. No. CAD 009 164 021

# **SGH Response to the DTSC February 26, 2020 Letter Comments**

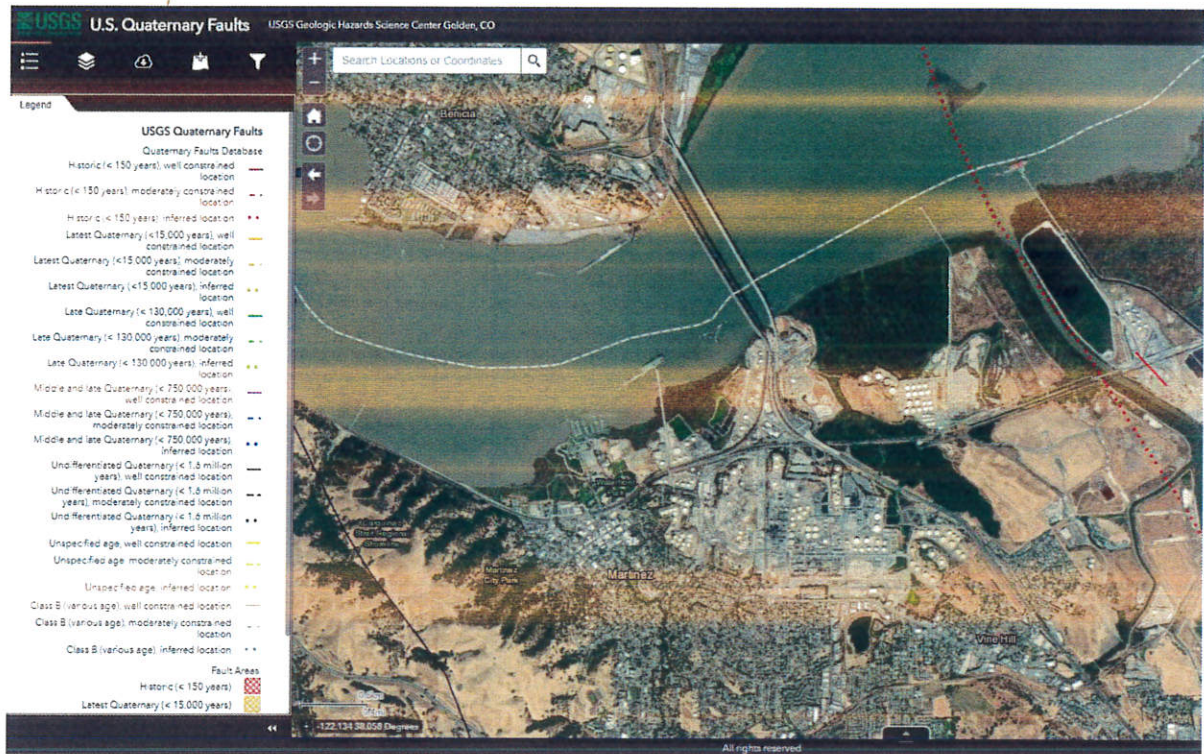
Figure 1: U.S. Geological Survey and California Geological Survey, Quaternary fault and fold database for the United States, accessed June 8, 2020, at: <https://www.usgs.gov/natural-hazards/earthquake-hazards/faults>.

The current USGS maps showing Quaternary Faults do not indicate known or suspected faults through this facility.

Figure 1 below shows a portion of the USGS interactive fault maps available online through the USGS website. The nearest fault is the main trace of the Concord Fault (in Red), approximately 2 miles to the E-NE of the site.

Pond 7 is near the center of the image. The nearest fault is to the east and does not trend toward the site.
